# *Citrus Rootstock Acquisition and Evaluation — 2018<sup>1</sup>*

The experiment is located in block 6E (Flood irrigated trees) and 6W (Drip irrigated trees) at the Yuma Mesa Agriculture Center, near Somerton, AZ. The 2016 and 2017 reports for this experiment can be found as a PDF files at: <https://agriculture.az.gov/arizona-citrus-research-council-previously-funded-research-projects>.

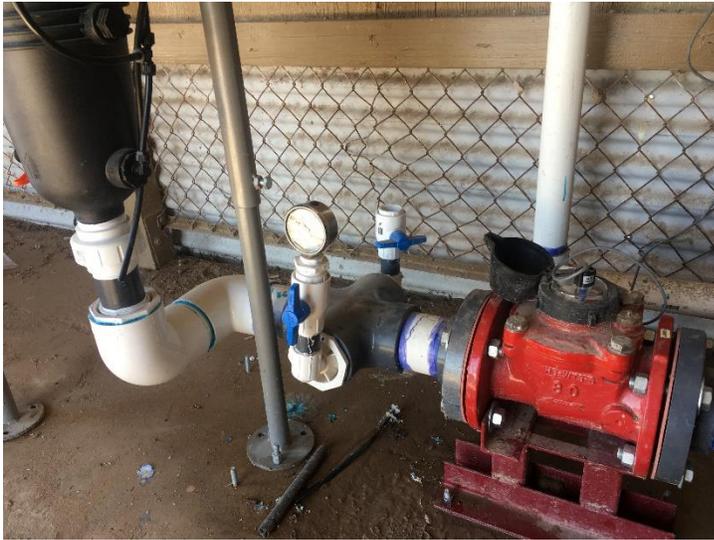
The original RainBird filter became inoperable and unserviceable and was replaced with an automated Netafim disk filter system. The Netafim water meter was jammed and required repeated dismantling to remove debris. This may require relocating the water meter down stream from the new water filter. See figure1.

Figure 1. New filter system and repaired water-meter.

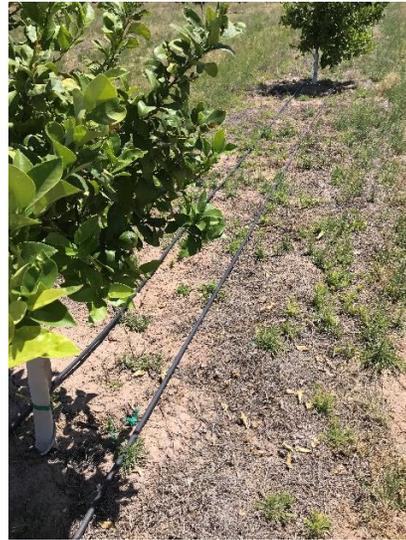
Figure 2. Rodent Control identification.

A more aggressive rodent identification and control program was initiated to control field damage. About 60% of the trees had one or more gophers at the base. The green flag in figure 2 shows one of the identified rodent burrows that required baiting. The rodent control effort is continuing, and we are seeing a significant reduction in burrows and damage.

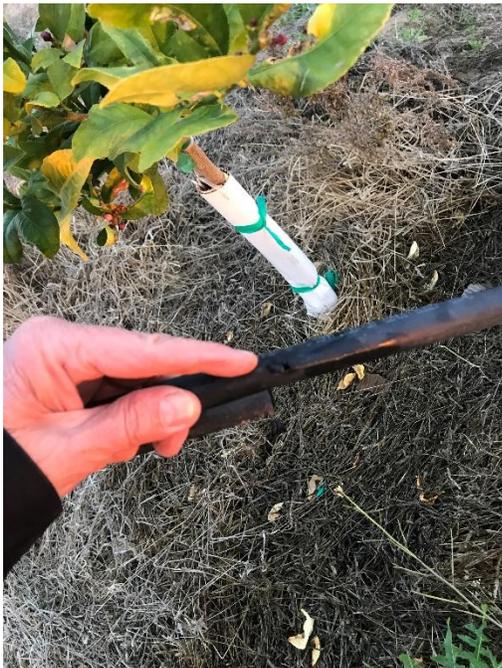
Figure 3. Rodent damage.

Both rodent damage (figure 3) and vandalism (figures 3, 4, 5, 6 and 7) had the same effect of creating breaks in the irrigation lines and wasting water by flooding areas of the field and creating dry spots in others. Some of the vandalism involved opening and closing exposed valves and while some lines appeared to be entangled in equipment and pulled out of location (see figure 4). The soil moisture probe was found to be faulty and will be replaced.

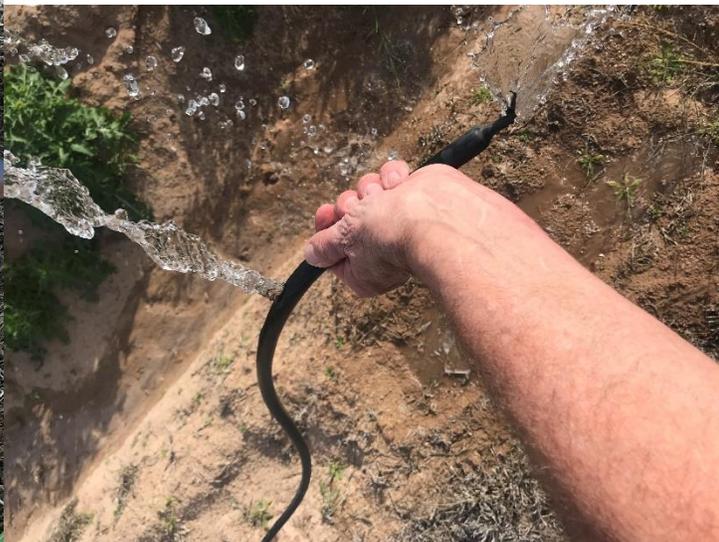
Figure 4. Damage due to equipment or possibly vandalism

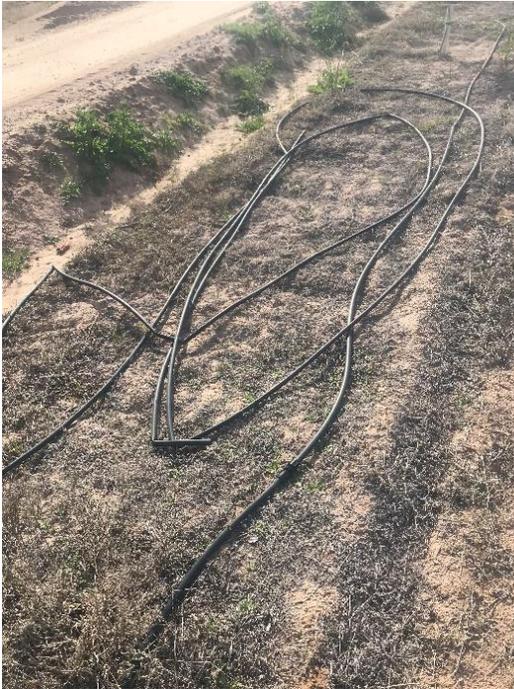
Figure 5. Vandalism

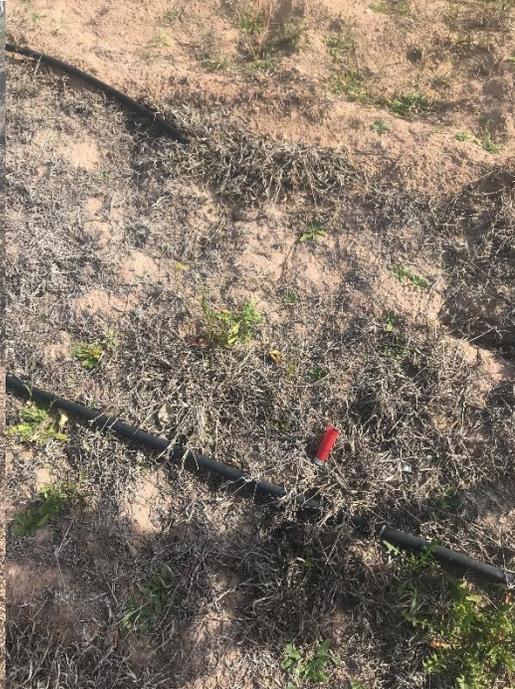
Figure 6. Vandalism by hunters

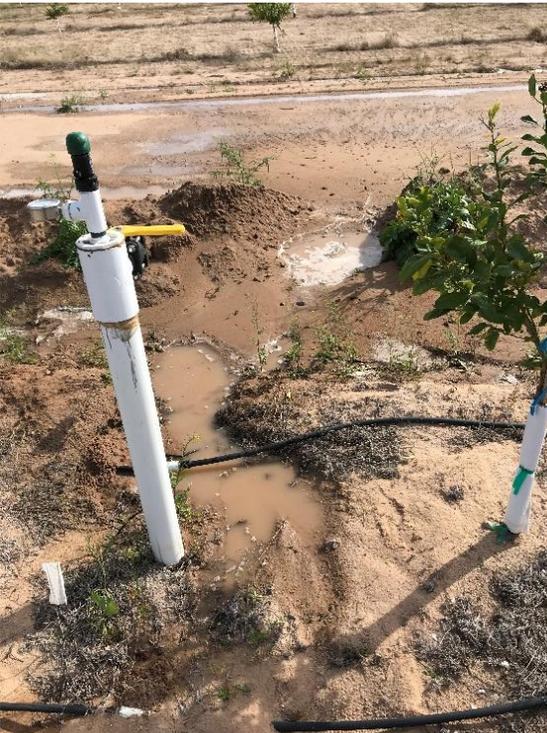
Figure 7. Vandalism (opened valves)

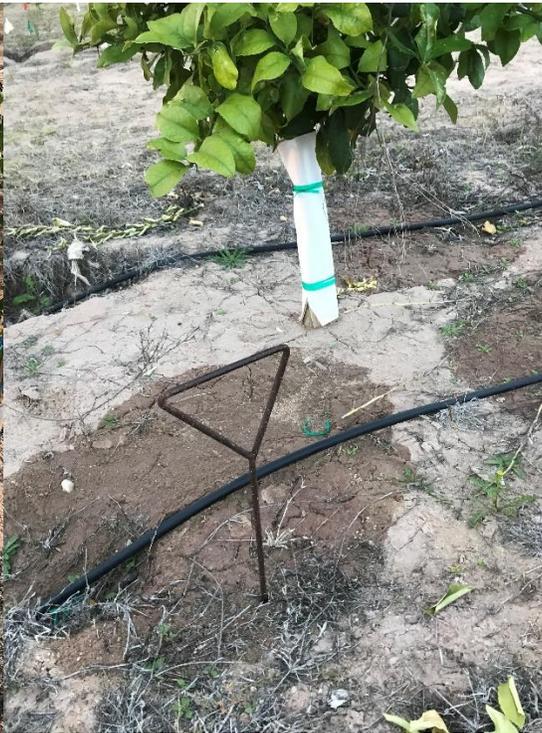
Figure 8. Proper drip irrigation

After all the adjustments and repairs to the system were made the drip irrigation system appears ready for full time service once the faulty soil moisture probe is replaced. Figure 8 shows the water infiltration to 24" depth after about a 3-hour irrigation sequence.
